Two-material rail development: field test results regarding rolling contact fatigue and squeal noise behaviour

Results from the European 5th Framework project “InfraStar” are presented. The InfraStar project is developing a two-material rail to increase the productivity and reliability of rail infrastructure. The two-material rail aims to be rolling contact fatigue (RCF) resistant and to reduce squeal noise.

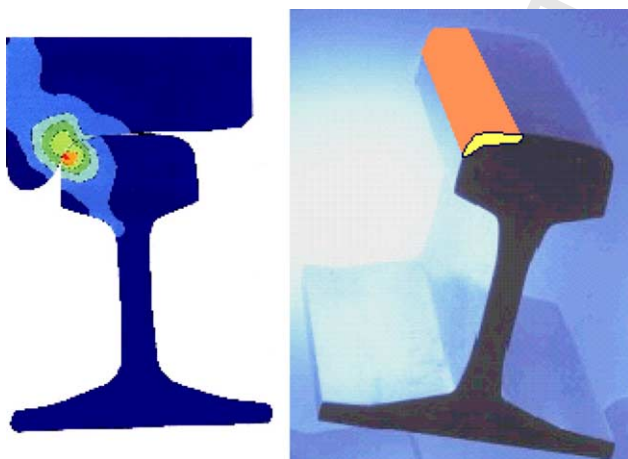
Fig. 1. Use surface layer with new alloys only where superior properties are required.

48 All the factors above are addressed in the European 5th
 49 Framework project InfraStar, which started in April 2000.
 50 The main goal of the project is to develop a railhead with
 51 an additional surface layer (the InfraStar two-material rail),
 52 which prevents rolling contact fatigue (RCF) and reduces
 53 noise emissions in small-radius curves (Fig. 1).

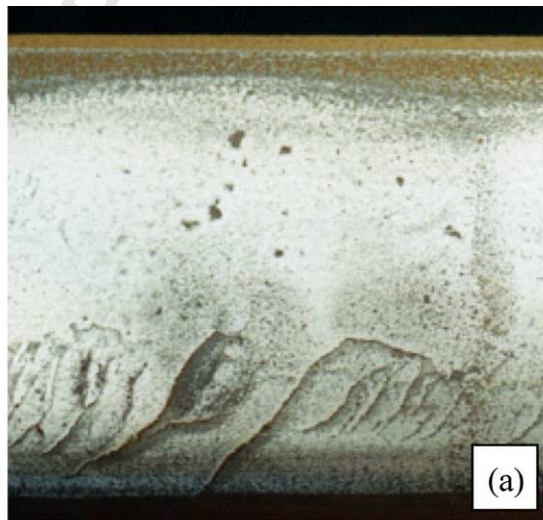
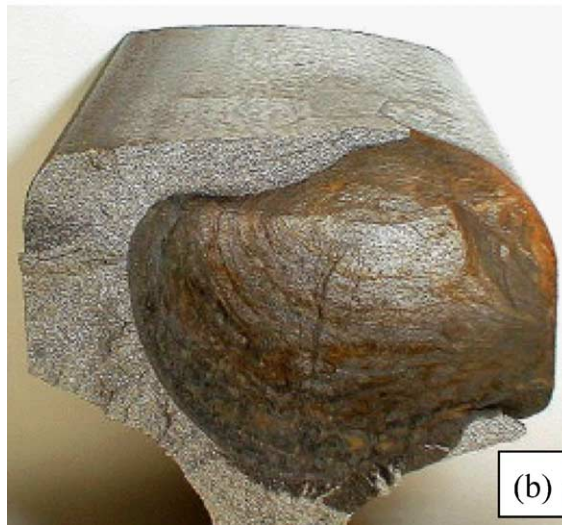
Fig. 2. (a) Head check cracking at gauge corner (top view of railhead); (b) transverse rail fracture from a head check.

54 Rolling contact fatigue is currently one of the major limi-
 55 tations of railway infrastructure productivity. Squats, shelling
 56 and head checks are all forms of RCF, but head checks
 57 are prevalent in curves and switches where flange contact
 58 towards the gauge corner may result in increased tangen-
 59 tial force/slip and decreased wheel–rail contact area. These
 60 surface-initiated cracks can ultimately lead to complete frac-
 61 ture of the rail (Fig. 2). In addition to RCF, high noise emis-
 62 sion (up to 100–110 dB) caused by stick-slip at the wheel–rail
 63 interface is one of the main environmental problems in Eu-
 64 rope.

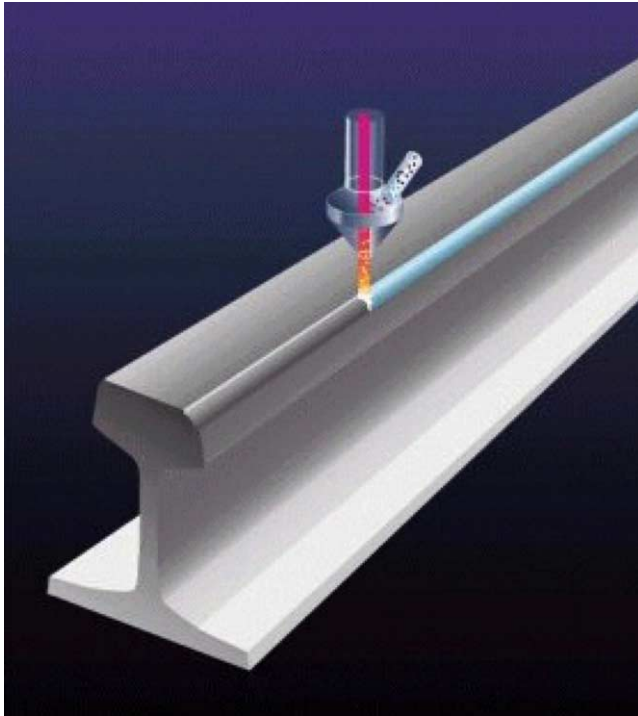
Fig. 3. The Duroc laser cladding application process.

74 The Duroc laser cladding technology (Fig. 3) is a surface
 75 and materials treatment process by which alloying materials,
 76 and even ceramic additives, in powder form can be com-
 77 bined to produce unique materials. The materials are chosen
 78 to provide the desired tribological properties, and the coat-
 79 ing is applied on the rail surface where such properties are
 80 required.

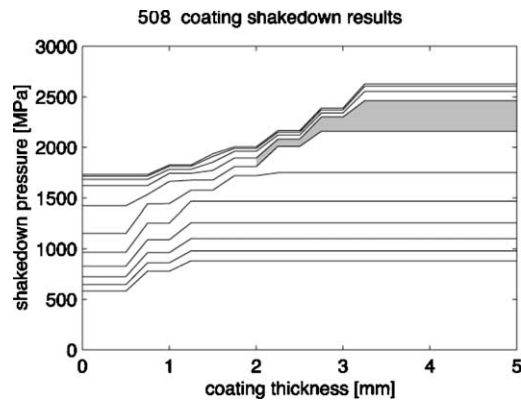
Fig. 4. Shakedown map for wheel–rail contact for the Duroc 508 coating. Results are based on 3D finite element calculations for friction coefficients from 0.0 to 1.0, from top to bottom.

Three-dimensional wheel–rail shakedown maps have been calculated and they can be used as an aid in coating selection, see Fig. 4 for an example. For the contact modelled here, the 508 coating thickness should be at least 3 mm thick for maximum strength, but contact pressure should not exceed 2500 MPa. The shaded region represents typical operating conditions for dry contact: friction coefficient between 0.3 and 0.4, coating thickness greater than 2 mm. For the 222 coating, the shakedown limit curves will be lower (because the 222 is 370 HV, whereas the harder 508 is 410 HV), but the traction coefficient (and also the friction coefficient) for the 222 is lower also.

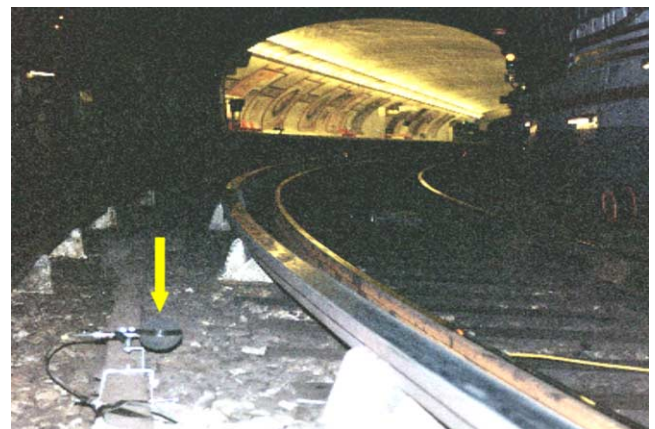
Fig. 6. Measuring position at test site (arrow points out microphone).

Outer rail: microphones at 1.6 m from the track centre and 0.20 m above the railhead (Fig. 6).

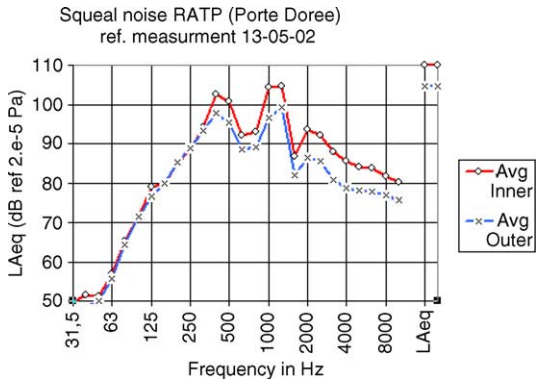
Fig. 7. Averaged LAeq value for inner and outer rails during reference measurements.

Because of the small differences in results between the different locations S1, S3 and S5, the results were averaged for the three sections. The spectra of these LAeq values are shown in Fig. 7.

All analysed measurements (average train speed 30 km/h), showed that the squeal noise appeared in the frequency domain 250–2000 Hz with two peaks, at 450 and 1200 Hz. This spectral signature was also observed during the test carried out in November 2000 by INRETS and RATP [9].

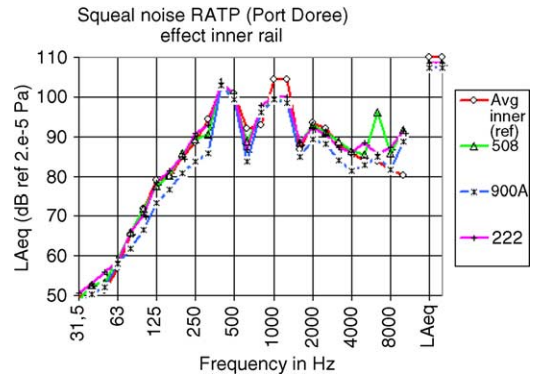
Fig. 8. Results from effect measurement on the inner rail. Spectra for the newly installed standard rail 900A (uncoated) and the 222 and 508 coated rails are compared to the reference measurement.

Fig. 8 presents the averaged spectra for the inner rails (outer rail spectra strongly resembles the inner rail spectra). In this figure, the results from the reference measurements (Avg inner ref in Fig. 8) are compared with the results from the effect measurements.

These spectral signatures of squeal noise are similar to the ones found in the reference measurements, with two emerging frequencies at 450 and 1200 Hz. The noise reduction due to the different measures appears in the frequency range 800–1500 Hz. For both inner and outer rails, the noise level

at the peak around 1200 Hz for the new 900A rail and both coatings is 5–8 dB(A) lower than the average level measured during the reference measurement.
